Water Compliance Inspection Report

Name and Location of Facility Inspected (For industrial users discharging to POTW, also include POTW name and NPDES permit number) North Star Terminal & Stevedore Co., LLC 790 Ocean Dock Road Anchorage, AK 99501	Entry Time/Date 9:20AM 10/04/16	Permit Effective Date 04/01/2015
	Exit Time/Date 11:45AM 10/04/16	Permit Expiration Date 03/31/2020
Name(s) of On-Site Representative(s)/Title(s)/Phone and Fax Number(s) Steve Black, Anchorage Operations Manager (907) 263-0121 steveb@northstarak.com	Other Facility Data (e.g., SIC NAICS, and other descriptive information) NAICS 488320 - Marine Cargo Handling ADEC MSGP Inspection	
Name, Address of Responsible Official/Title/Phone and Fax Number Steve Black, Anchorage Operations Manager (907) 263-0121 North Star Terminal & Stevedore Co., LLC 790 Ocean Dock Road Anchorage, AK 99501	Contacted <input checked="" type="checkbox"/> Yes <input type="checkbox"/> No Lat: 61.228052 Long: -149.895144

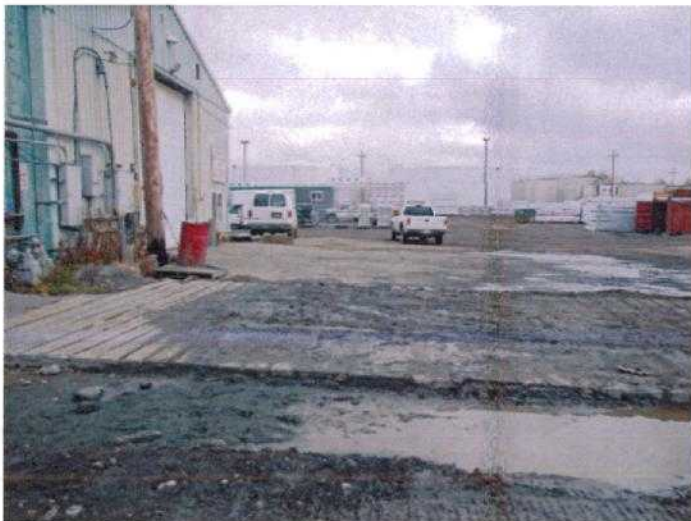
Photo #25

Description: Facing north, photo of the pressure washing area on the east end of the maintenance shop. Camera Photo DSCN1163.

At the time of inspection, I observed a buildup of sediment/material at the wash down area. A stormwater catch basin is located approximately 25 feet away. The catch basin had an adsorbent boom around which was in need of maintenance. No controls were in place to prevent water from the pressure washing area from discharging into the stormwater collection system. See Attachment E, Photo Log, Photo #24 & #25.

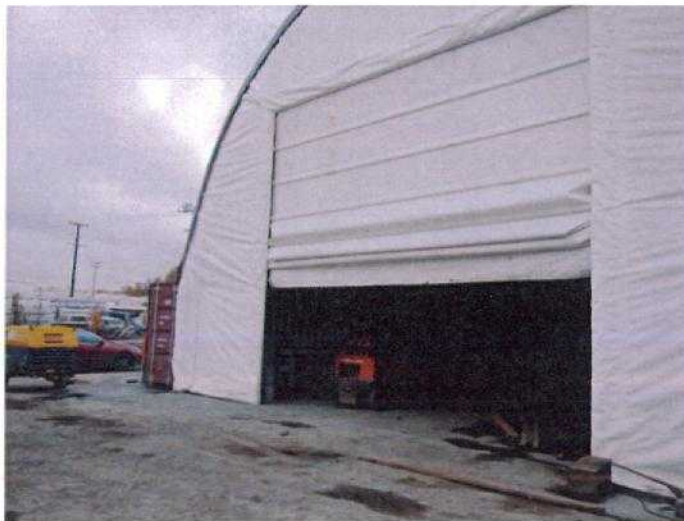
Photo #26

Description: Facing northeast photo of the facility's paint shed. Camera Photo DSCN1164.

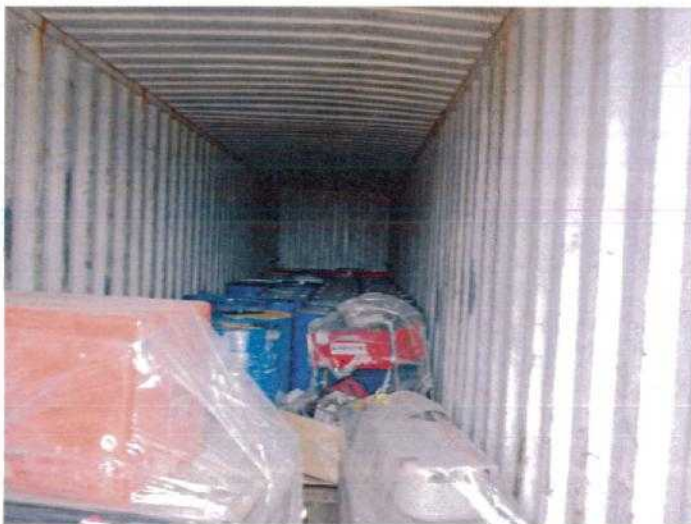
Photo #27

Description: Photo of inside a shipping crate used for material storage. This area was near the south end of the maintenance shop. Camera Photo DSCN1165.

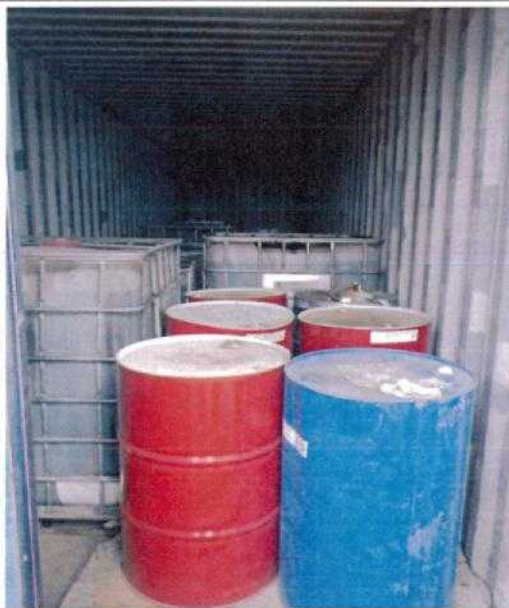
Photo #28

Description: Photo of inside a shipping crate used for material storage. This area was near the south end of the maintenance shop. Camera Photo DSCN1166.
